Application Case Study – TRW Automotive, Shanghai, China

Automated vision inspection and parts traceability in automotive assembly process

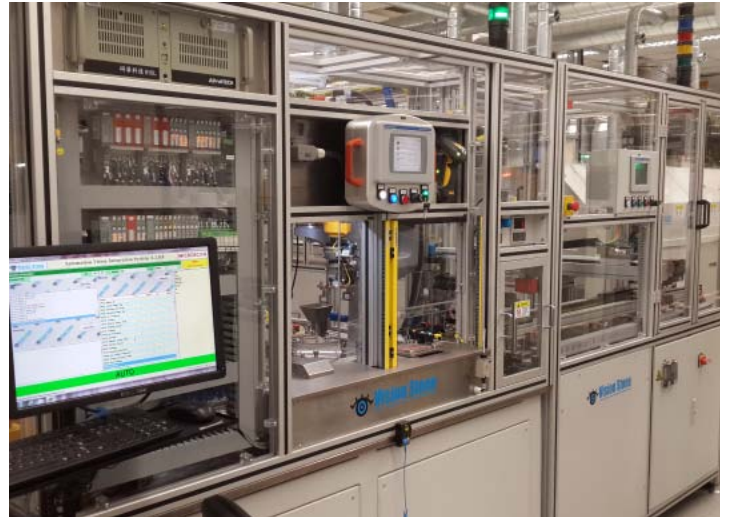
Vision Stone developed and installed a custom-made vision inspection system for TRW with multiple smart cameras from Microscan.

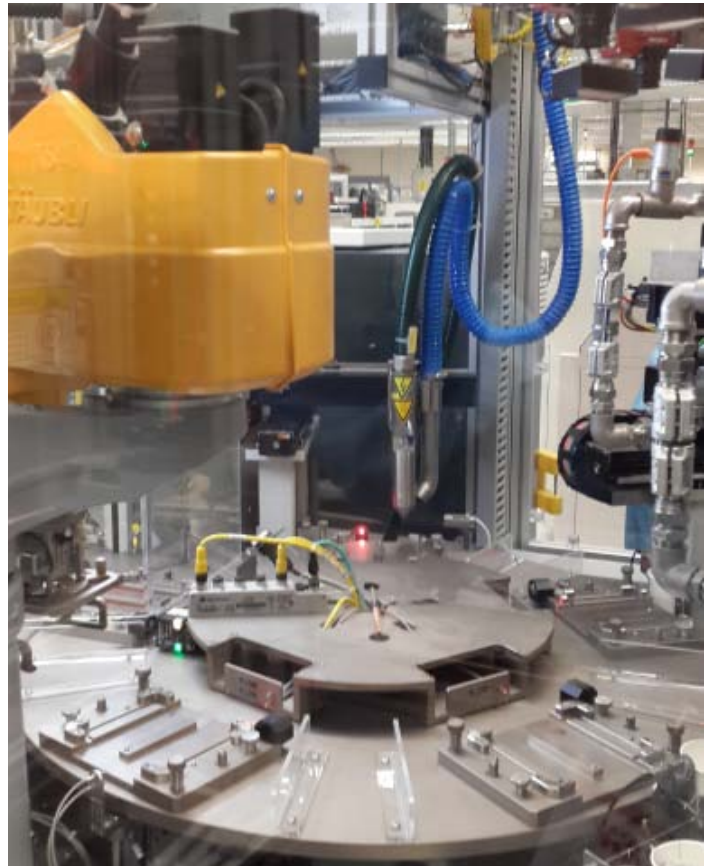
Microscan's Vision HAWK is integrated into a robot arm for vision inspection on the assembly line.

It checks that there are no air bubbles in the glue used for sealing to ensure coating integrity, before the products go into the oven.

In addition to making sure that the individual components are inserted into their correct positions, the vision system checks the solder position, the sealant and cooling gel position, and gel coverage rate on the cover. The cooling gel coverage is vital as too little of it will cause the parts to become too hot, and too much gel will affect the appearance. The components are also inspected to test for polarity, positioning or damage. The solder inspection is very important because if the stitch is even slightly bent, the product will be scrapped. Machine vision inspection of the sealant and cooling gel position will enable automated rejection of incorrect parts, without having to stop the assembly line.
