Application Case Study – Van-Rob, Inc., Aurora, Ontario, Canada

Tier One Automotive Supplier Ensures Quality of Grille Opening Reinforcements with Marking and Decoding Solution

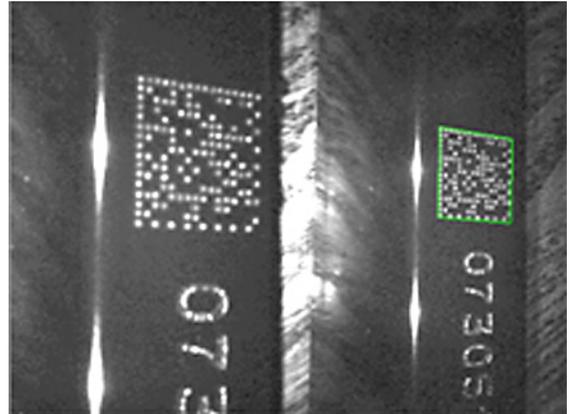
The rectangular metal tube base component marked with a 2 mm Data Matrix symbol.

The manufacture of grille opening reinforcements in Van-Rob facilities includes the application of Data Matrix symbols directly to a base component that is then laser-welded to the larger assembly. The Data Matrix symbols must be scanned at multiple stages to monitor laser weld quality tracking. The base component is a rectangular tube to which Data Matrix symbols must be applied prior to entry into the welding process. The tube is welded into the grille opening reinforcement sub-assembly. The symbols on the tube are scanned at the first and second welding stages.

Van-Rob's engineers knew that a process of this relative complexity required both a dependable marking device and a handheld reader that could reliably decode direct part marks (DPM) before and after the e-coating stage. If the mark were too shallow, for example, the Data Matrix symbol's cells might be subject to overfill during e-coating,

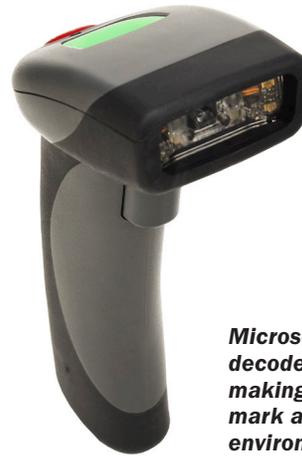
Microscan's HS-41X features X-Mode decode algorithms and a rugged design, making it an ideal choice for direct part mark applications in tough industrial environments.

It was determined that the Technifor XF510Cp dot peen marker and Microscan's HS-41X Handheld DPM Reader would be ideal for reliable marking and reading of Data Matrix symbols on the rectangular metal tube base component, before and after e-coat. Using bare and e-coated metal tube samples provided by Van-Rob, Clearview submitted the evaluation report demonstrating the HS-41X's ability to read the XF510Cp's Data Matrix symbols with 100% consistency and accuracy in varying ambient lighting conditions. The optimal read range was determined to be anywhere from 2" to 8" from the reader to the mark, depending on symbol size and whether or not the part was e-coated. It was found that the optimal read angle was 15 to 45 degrees, and that Data Matrix symbols could be decoded by the HS-41X in any position within a full 360 degrees of rotation. A common configuration file was used for all readers in Van-Rob's facilities, which use many Microscan handhelds throughout their process. The versatility of both Technifor's marking device and Microscan's handheld reader make them both ideal for Van-Rob's needs.
